UNITED STATES
DEPARTMENT OF THE INTERIOR
BUREAU OF MINES
HEALTH AND SAFETY ACTIVITY

REPORT OF FATAL COAL OUTBURST (BUMP) ACCIDENT
SOMERSET MINE
UNITED STATES STEEL CORPORATION
WESTERN-DISTRICT COAL
SOMERSET, GUNNISON COUNTY, COLORADO

January 11, 1967

V. H. Bowling Federal Coal-Mine Inspector

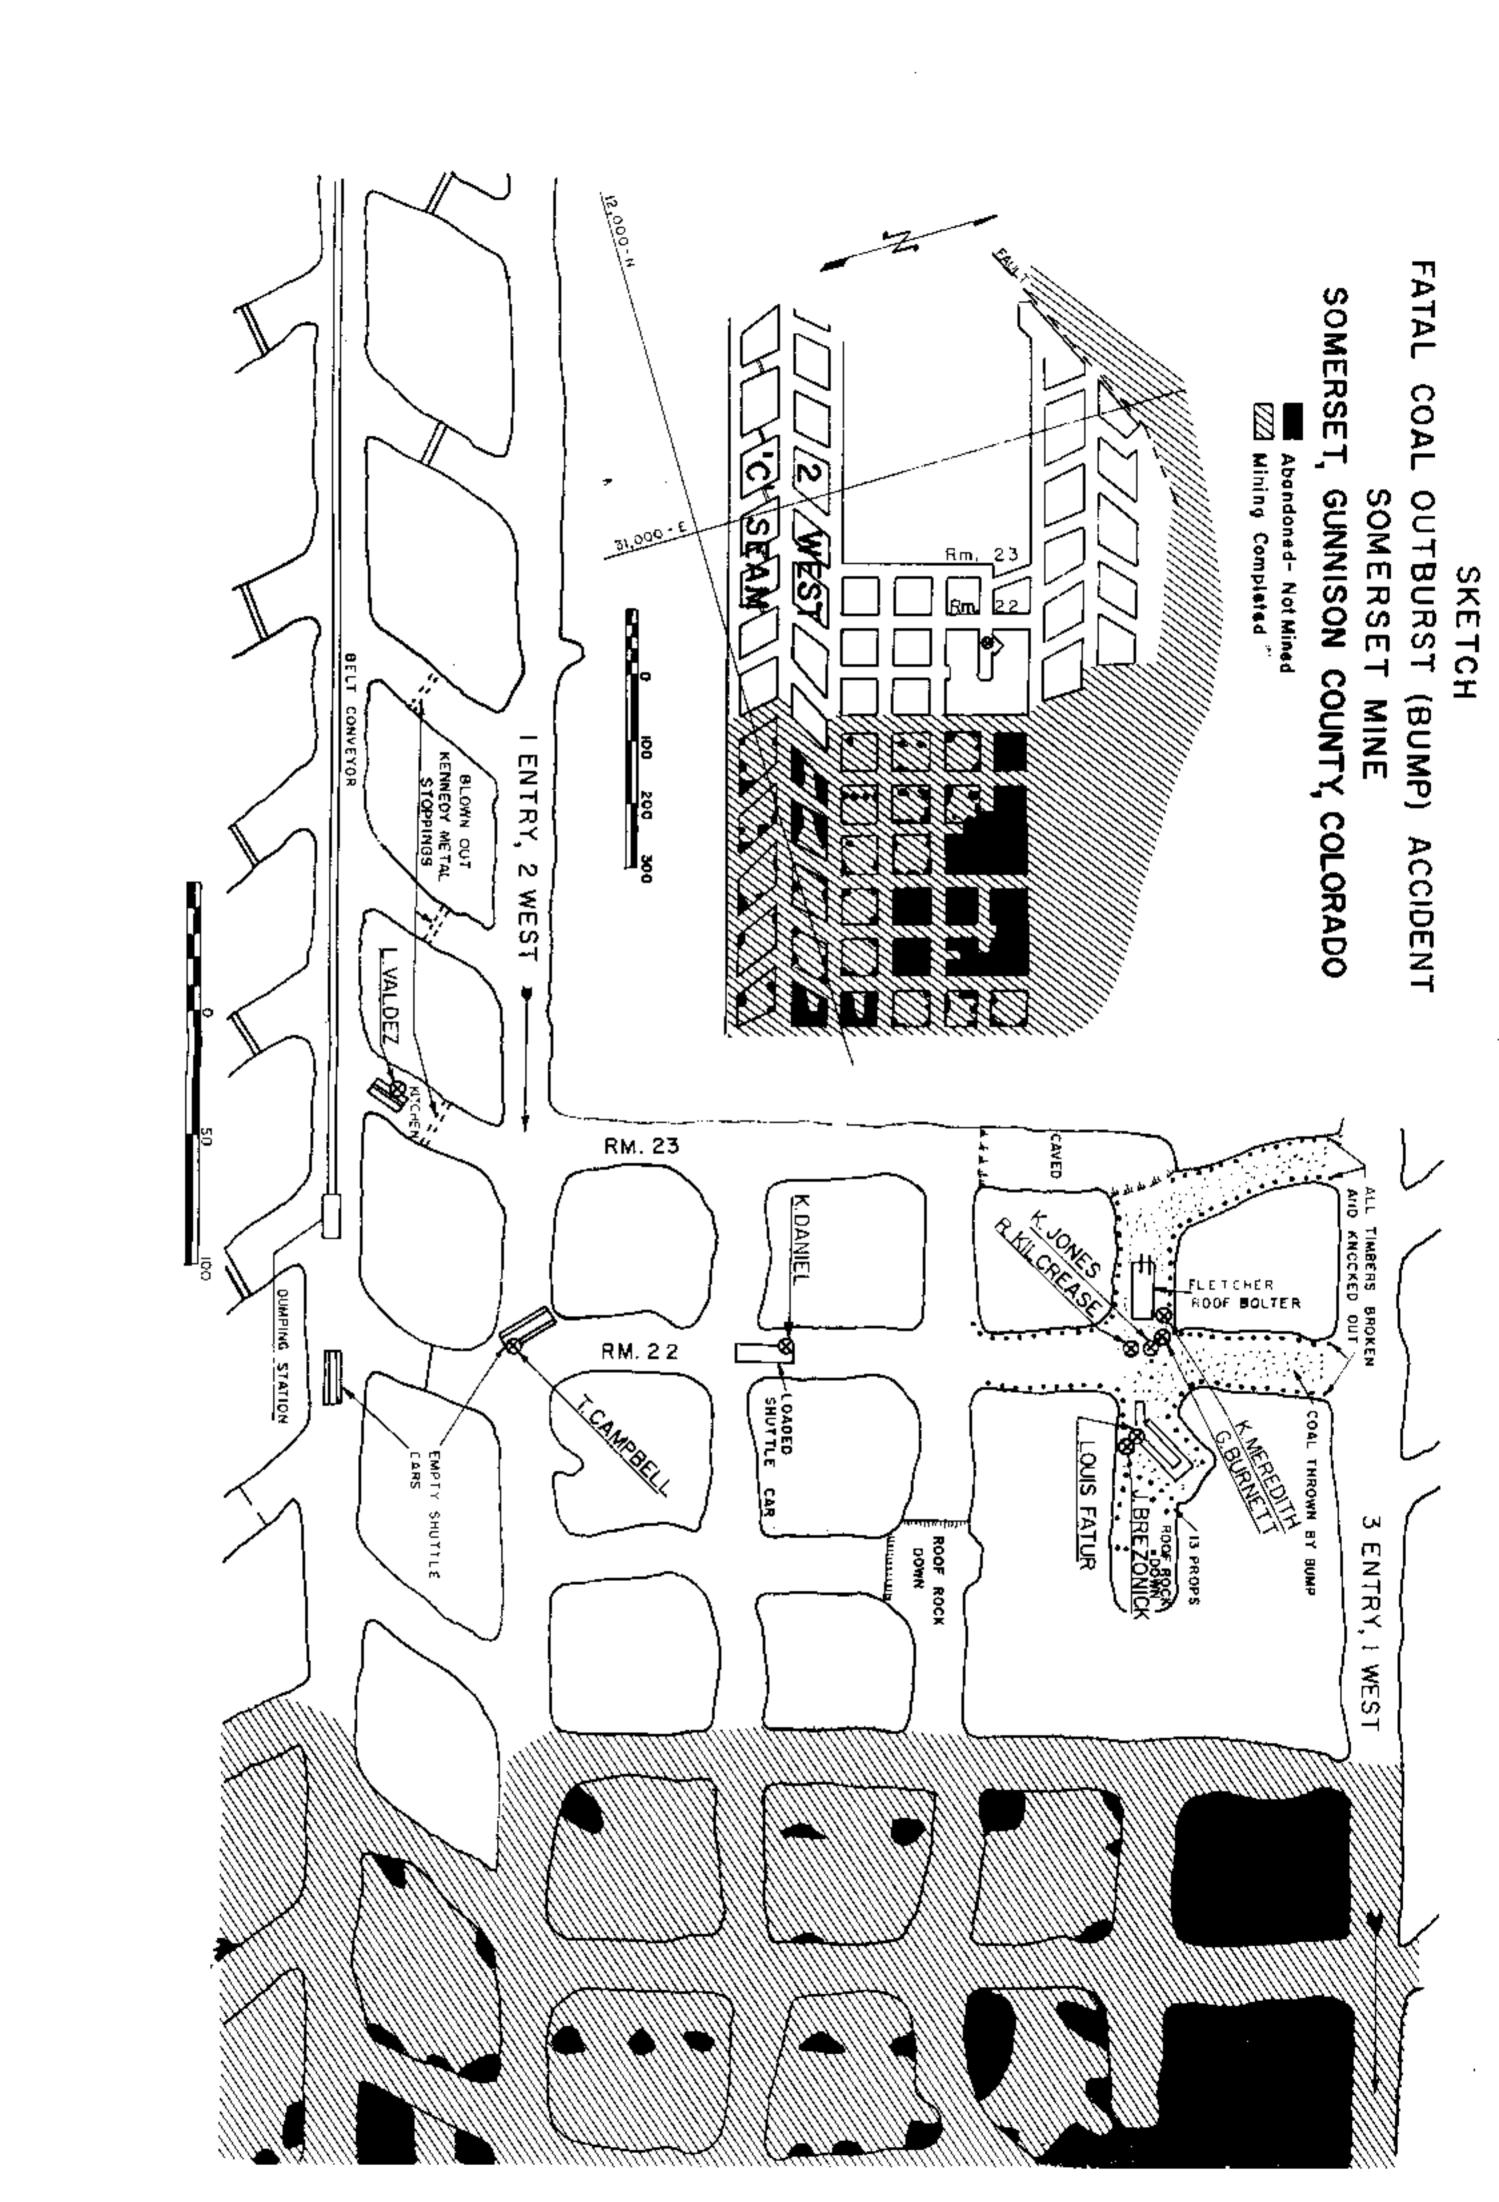
The 2 west section was retreating toward a fault and had retreated outby a rock spar. Because of a roof fall at some prior date, No. 21 room was not driven to its full depth and the block of coal through which the crosscut was being driven was about 175 feet square. The crosscut had been driven to a depth of about 80 feet. Because of the amount of roof rock coming in as the coal was mined, the section foreman called the acting mine foreman and requested permission to pull out of the crosscut, It was agreed that the miner would be pulled back to a point about 50 feet from the face and that a lift to the left would be started in an attempt to drive through to the old No. 3 entry, 1 west. After the miner was pulled back, 13 props were set in the vacated area, and the lift was started to the left on about a 45-degree angle. A shallow cut was made to permit the bolting crew to bolt the roof and catch up the cap rock. The continuous miner then was removed so that the roof could be bolted. After the roof in the face area was bolted, the bolting machine was parked in the crosscut between No. 23 and No. 22 rooms (directly in front of the crosscut where the lift was bolted). Meredith and Burnett, the roof-bolting crew; Jones, the timberman; and Kilcrease, the section foreman, all were standing at the intersection near the parked roof-bolting machine.

The investigation revealed that in addition to the blown-out stoppings, the steering device was broken off the roof-bolt machine and a digger-head assembly had been broken off the mining machine, practically all timbers were broken and dislodged, and the 50-foot area from the face of the crosscut to the outby end of the miner was filled completely with loose coal. Coal and debris filled No. 22 room about 4 feet deep from the end of the miner outby to the end of the pillar. The concussion caused by the outburst was felt by workmen approximately 1½ miles away, and considerable disturbance was evident along the 2 west B seam haulageway directly beneath the C seam workings. This area was between the fault and rock spar present in both seams.

- 1. Natural conditions were conducive to coal outbursts--up to 1,500 feet of cover, a main roof of thick sandstone, and a hard firm shale floor resistant to pressure.
- 2. Pillars of unequal dimensions and shapes possessing different load carrying capacities were formed during previous and recent mining. The pillar involved was the largest in the area, approximately 175 feet long and 175 feet wide. It was situated between several other large pillars left from previous mining in the 1 west section, and large blocks of coal left in Nos. 18, 19, and 20 rooms (see sketch).
- 3. The extraction line was approaching a fault line.

- 1. Pillars should be extracted as completely as possible and pillar remnants should not be left; when it is impossible to recover remnants safely, they should be destroyed by blasting.
- 2. Where recovery of pillars is impracticable, pillars of uniform size and shape should be left, so that the stress is distributed uniformly upon all blocks.
